Manhole Inspection Summary

Manhole # S43AA_032MH

Insp Date: **3/9/10 10:30 AM**

Location Address: **Madison**

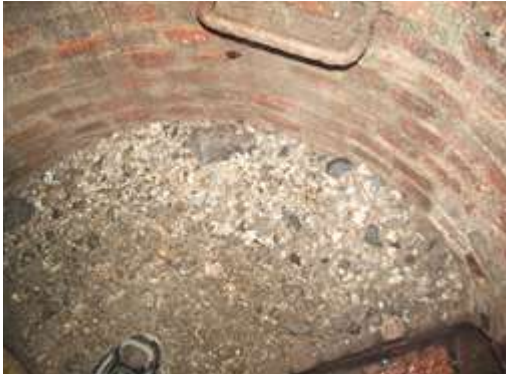
Defect 2

debris

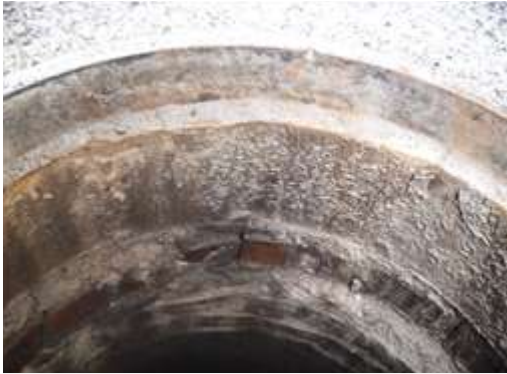
Defect 1

☒ **Leaks**

frame leaks

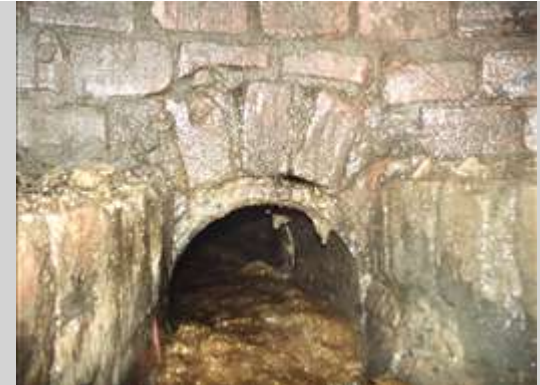
12 O'Clock Outflow

Pipe Height: **12** (in.) Rod and Bar (Angled)
Pipe Material: **Clay** ☐ Pipe Lined
Invert Depth: **11.25** (ft.) Flow Characteristics: **Fast**
Deposits: ☒ None ☐ Mud ☐ Sludge ☐ Debris ☐ Grease
Silt Depth: (in.) Deposits Extent:
Infiltration: **None** Pipe Seal Cond: **Sound**

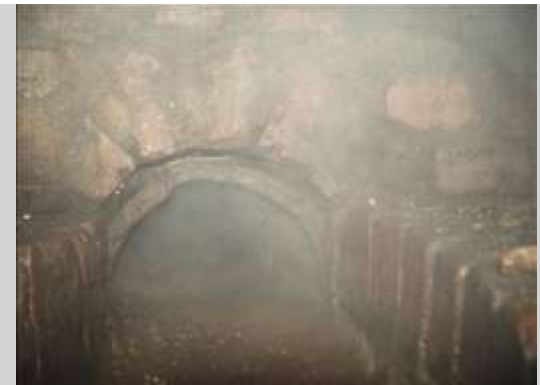
3 O'Clock Inflow

Pipe Height: **12** (in.) Rod and Bar (Angled)
Pipe Material: **Clay** ☐ Pipe Lined
Invert Depth: **11.17** (ft.) Flow Characteristics: **Turbulent**
Deposits: ☒ None ☐ Mud ☐ Sludge ☐ Debris ☐ Grease
Silt Depth: (in.) Deposits Extent:
Infiltration: **None** Pipe Seal Cond: **Sound**
